Failure Evaluation of Galvanized High Carbon Steel Spring Wires

Y.Z. SALIK^a, E. ALTUNCU^{b,*} AND F. ÜSTEL^c

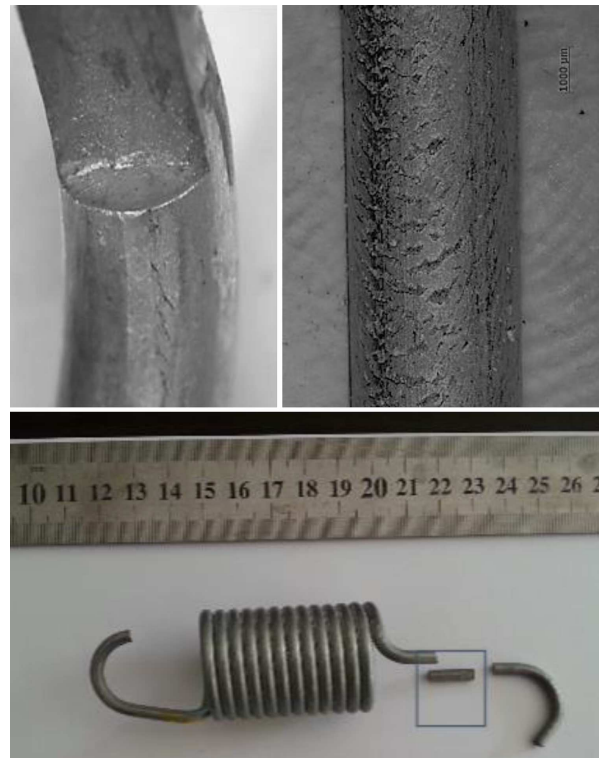
Main causes of breakage of fatigue are: improper metallurgy, chemical composition, incorrect forming profile, excessive wire reduction, segregation, decarburisation, porosity, and other surface defects. It has been observed that the springs do not have sufficient fatigue life. Cracks and deformation traces are observed on steel spring surfaces (Fig. 2). In this context, input wire rod quality control tests were started to determine the microstructural discontinuities that will affect the spring failure.

Fig. 2. Surface of the damaged spring wire.

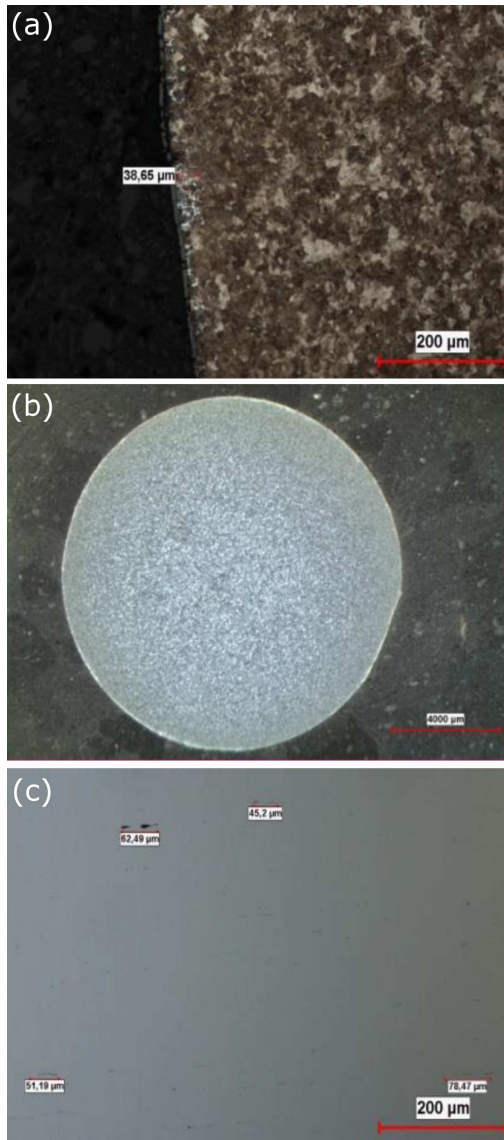
Decarburisation and segregation can significantly reduce strength and fatigue life of the steel. Decarburisation problems must be avoided. It is necessary to control decarburising depth for both rod and wire. Microstructural discontinuity was not observed as a result of the tests made in accordance with the relevant standards (decarburisation depth: ISO 3887:2003 (ISO 3887:2017; segregation: BS EN ISO 16120-1:2011; inclusion: ISO 4937:2013; surface discontinuity: BS EN ISO 16120-1:2011) in Fig. 3.

Fig. 3. Wire rod input quality control test results: (a) decarburisation depth, (b) segregation, (c) inclusion.

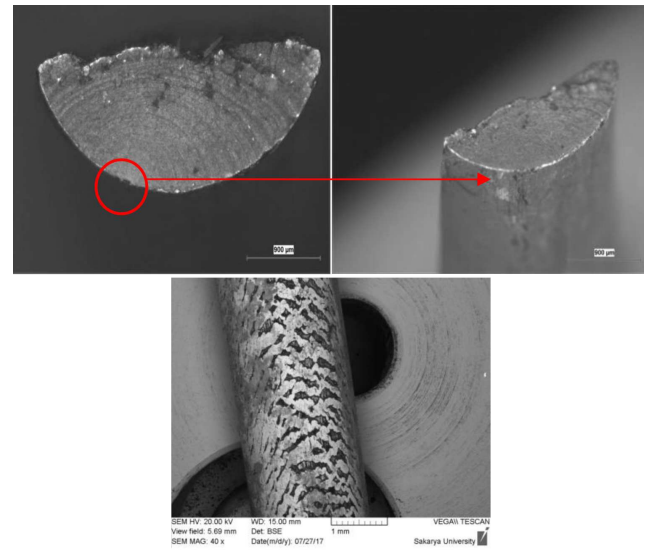
It is understood that typical fatigue fracture damage occurs when the fracture zone is examined, as shown in Fig. 4. It was determined that the crack initiation occurred in regions near the surface. It is observed that the discontinuities on the surface cause crack formation and that the fracture occurs after increasing repeated stresses. It is predicted that these surface defects will occur during wire drawing operations.

Fig. 4. Fracture surface and wire surface defects on spring wire.

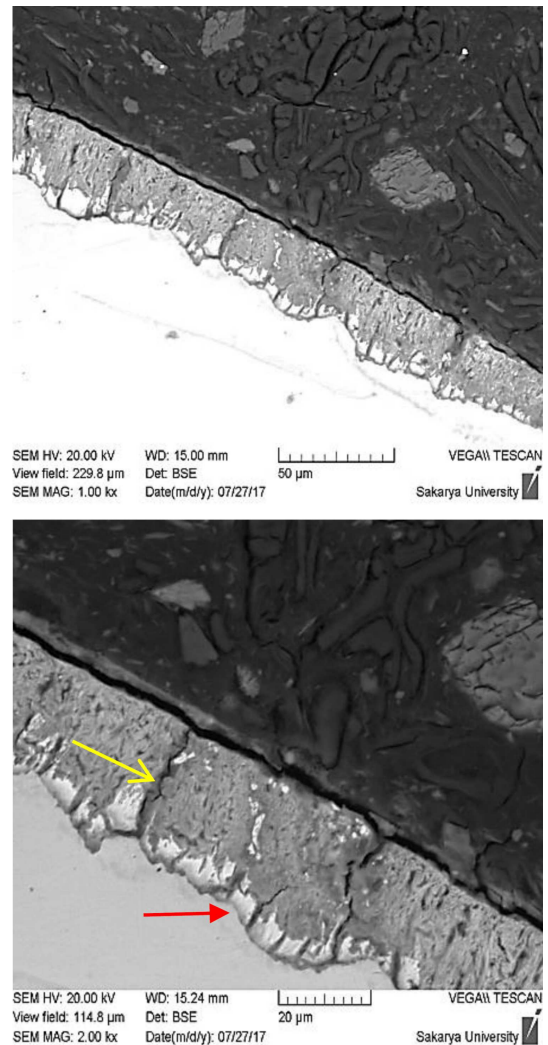
Coating thickness is between 30–35 µm. Various intermetallic (Fe–Zn) phases were detected in the coating structure. Vertical cracks are detected along the transverse section of the examinations made on the coating surface. There are also metallurgical phase differences along the coating thickness. This indicates that the cooling process is not suitable. Adhesion properties at the interface between the coating and the substrate are very poor, as shown in Fig. 5. As a result of EDX analy-

Fig. 5. Zinc coating microstructure and surface defects.

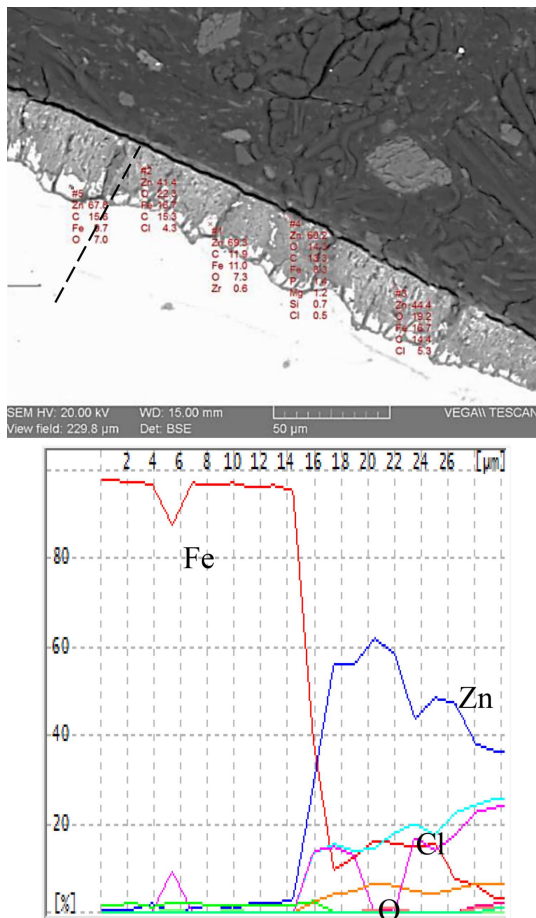
sis in the coating section, it was assigned to Cl and O elements. This shows that the surface preparation before the coating process is not sufficient, as reported in Fig. 6. Corrosive products (FeCl, FeO based) occurred at the interface as a result of acidic reactions.

Fig. 6. EDX line analysis of the zinc coating layer on steel wire.
